DEPARTMENT OF THE TREASURY AUCTION

**PARC RIVIERA APARTMENTS
5130-5222 BELMONT AVENUE
DALLAS, TEXAS 75206
IRS2004-7406-50001-01-001**

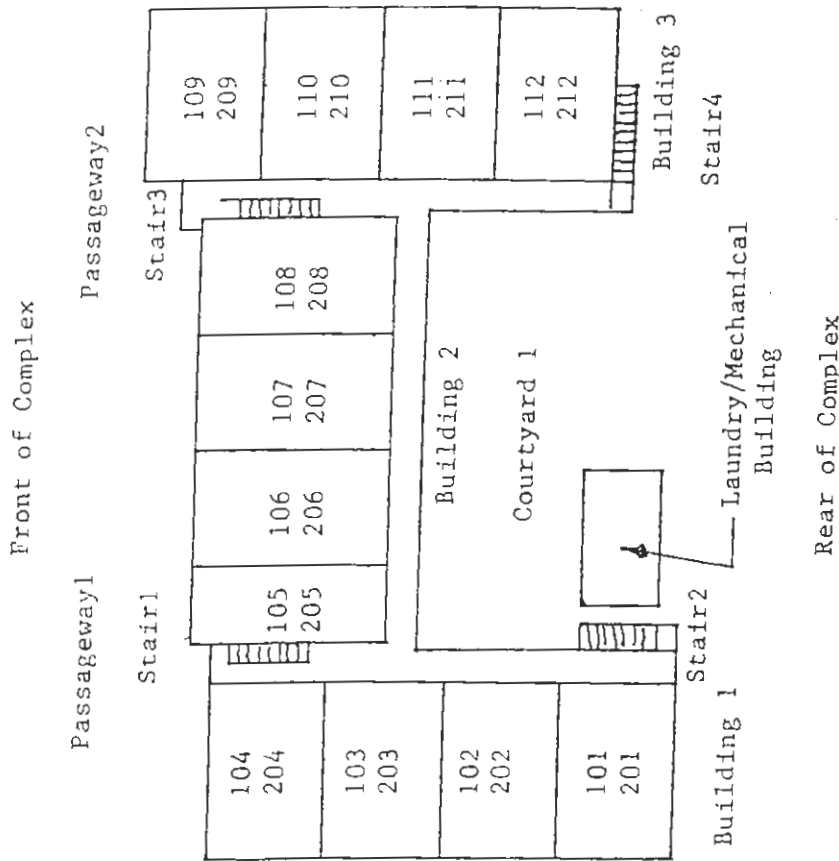
COMPLEX 2

The Complex 2 property consists of a two-story multi-family apartment complex with 24 individual apartment units - 12 units each floor. There are 3 separate buildings connected together by exterior open passageways and stairways and walkways, and by an adjoining roofline, to give the appearance of one single complex building. Each of the buildings is constructed of conventional wood frame interior and brick veneer (and some wood siding) exterior and founded on a pier and beam foundation. The original construction date may or may not be the same as Complex 1. For orientation purposes, the complex also faces north.

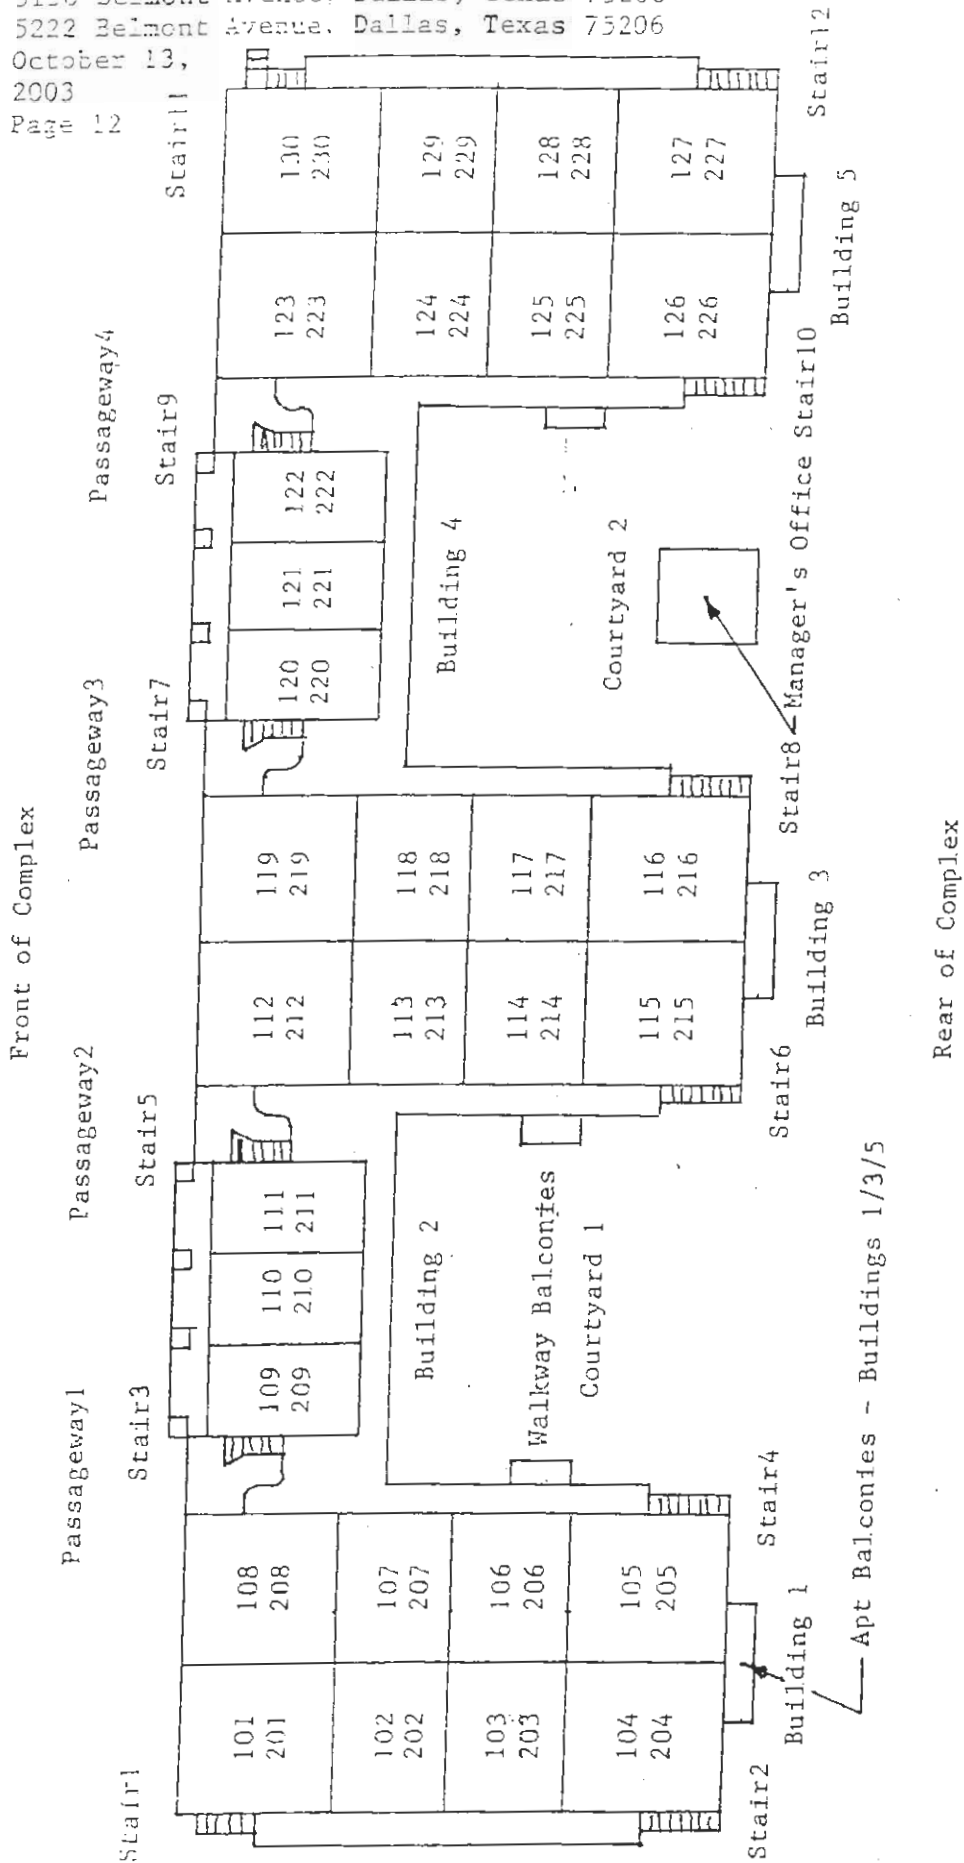
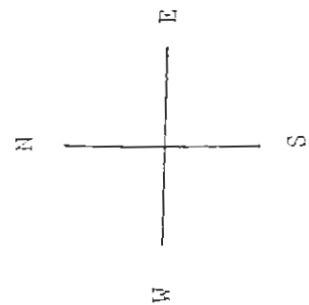
COMPLEX 1

The Complex 1 property consists of a two-story multi-family apartment complex with 60 individual apartment units - 30 units each floor. There are 5 separate buildings connected together by exterior open-air passageways and stairways and walkways, and by an adjoining roofline, to give the appearance of one single complex building. Each of the buildings is constructed of conventional wood frame interior and brick veneer (and some wood siding) exterior and founded on a pier and beam foundation. The original construction date was reported to be 1961. For orientation purposes, the complex faces north.
